# Portage Creek Sediment Remediation Project Kalamazoo, Michigan

Pre-Sediment Removal Structure Feature Assessment  
Removal Areas SA1-A, SA1-B and SA1-C

**FLEIS & VANDENBRINK  
ENGINEERING, INC.**

F&V Project Number: 809930  
May, 2013 (Updated June, 2013)

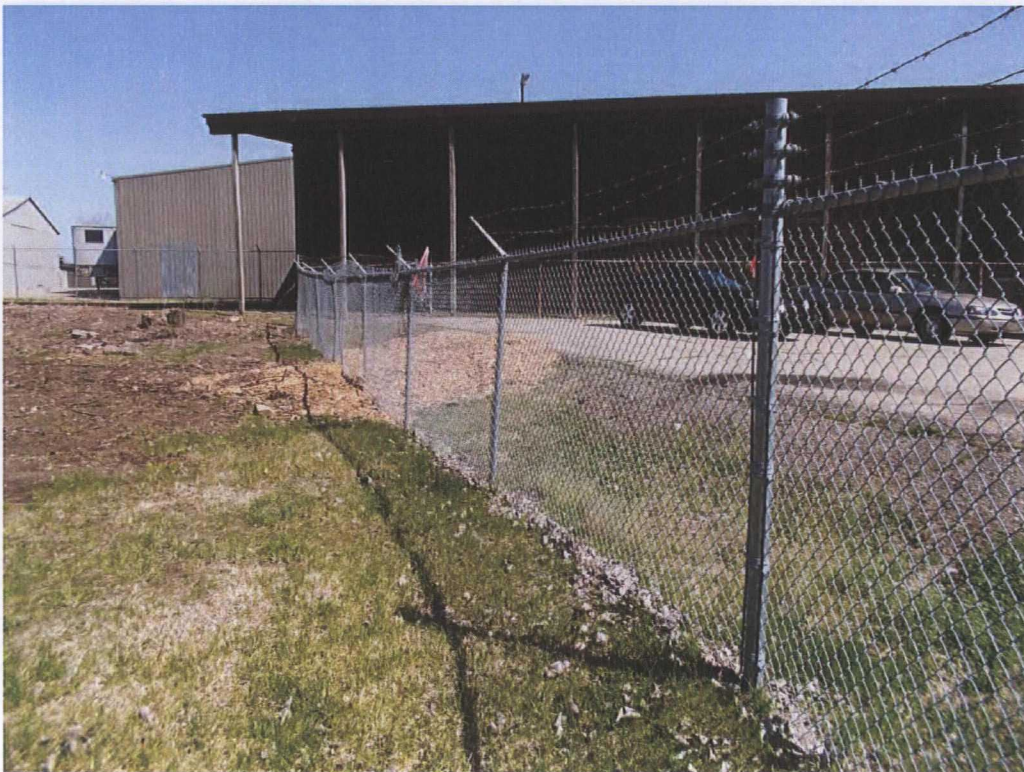
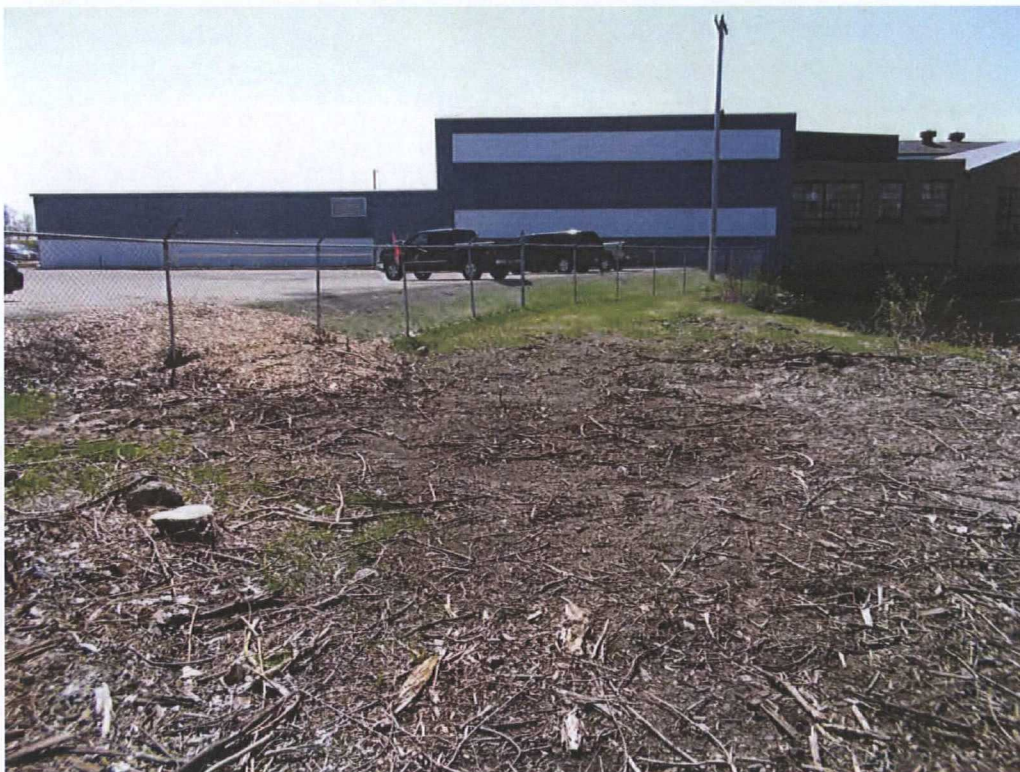
View of fence looking north

View of fence looking south

- If the fencing conflicts with sediment removal operations, it should be removed and replaced in kind.

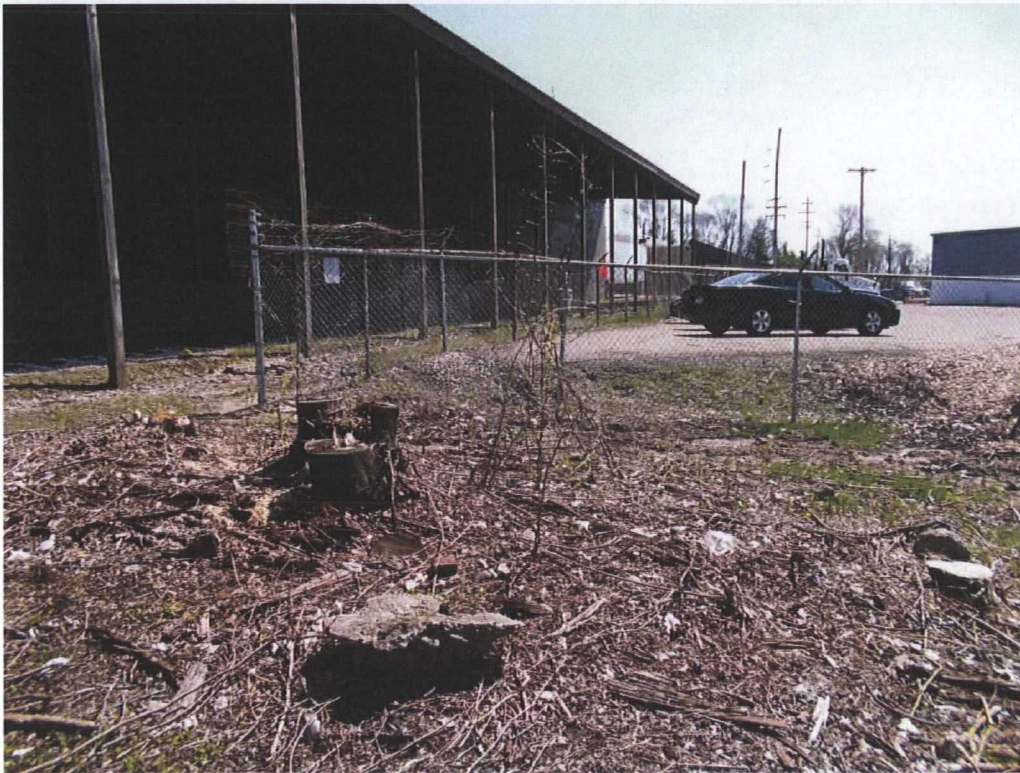
- The fence is generally in good condition, however, the barb wire has failed at the north end.

Failed barb wire at north end of fence

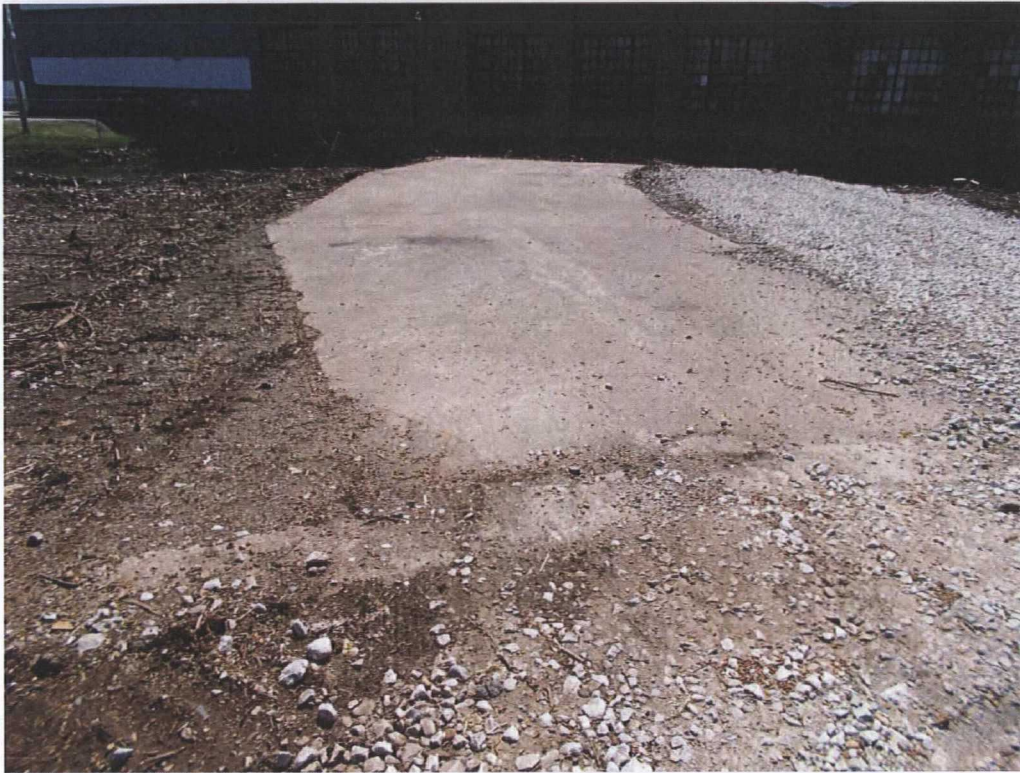
- The pavement appears to be abandoned. It is in fair condition with scattered minor to moderate cracking.
- The top of bank is eroded along the channel side of the pavement.
- There is a 2-3" void in the interior area of the pavement.
- A stone access road has been constructed around the pavement.

View of pavement looking south

- The pavement appears to be abandoned. Any damage done during sediment removal operations does not likely need to be addressed.

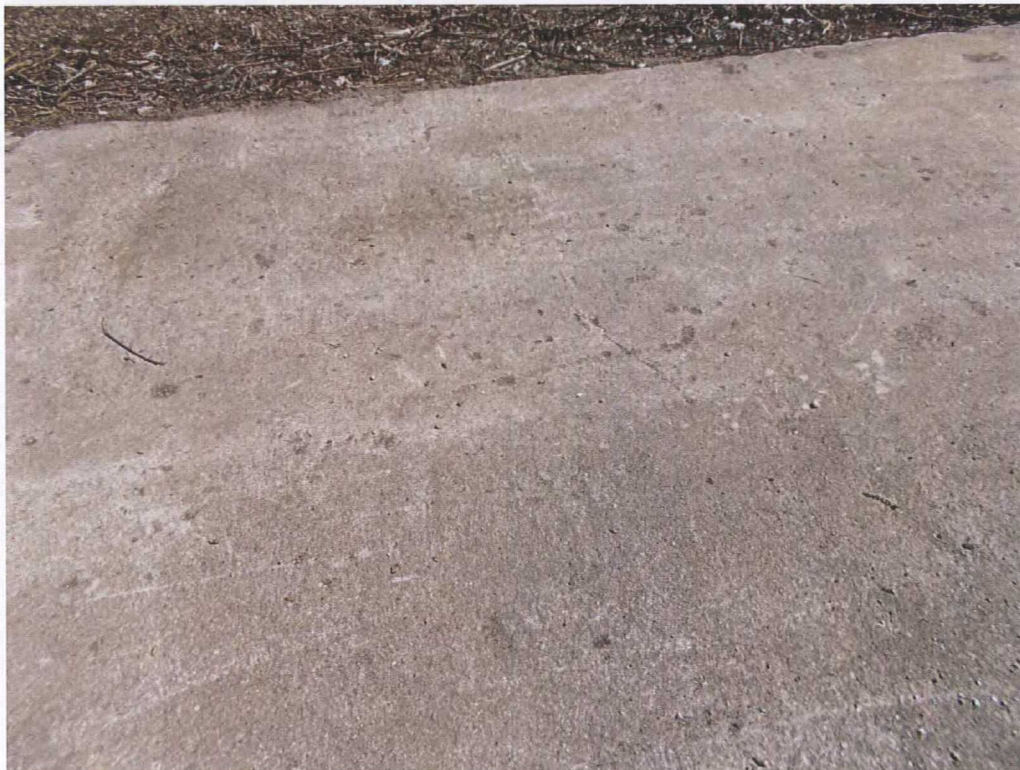
Cracking in surface of pavement

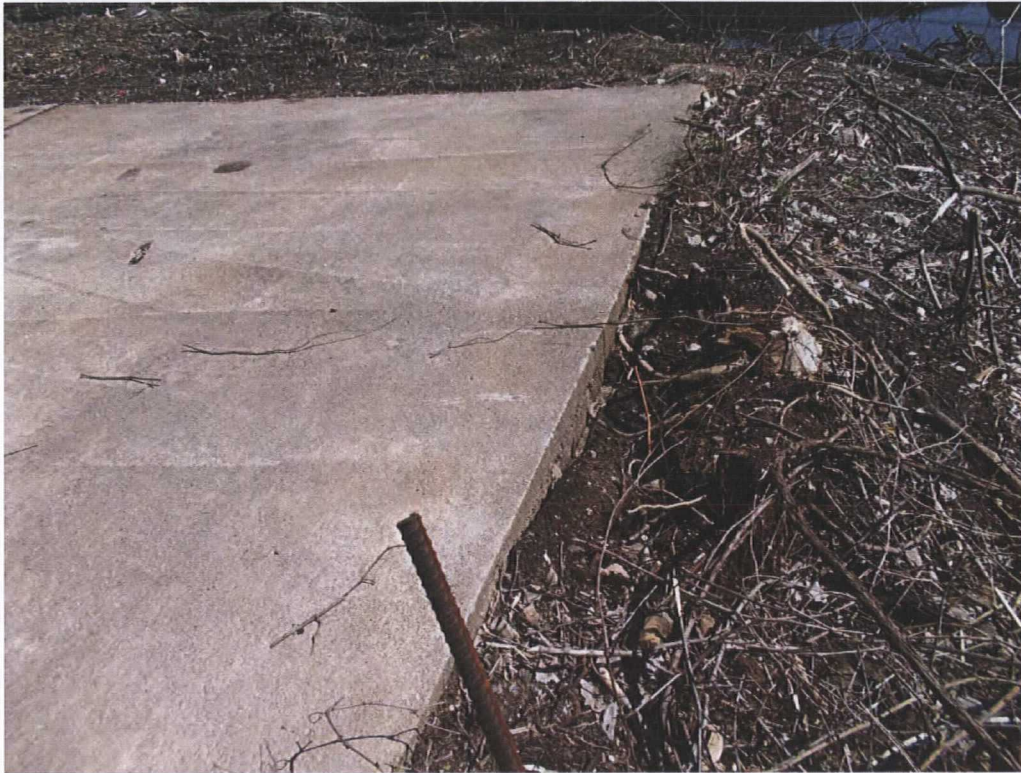
Erosion of top of bank along pavement

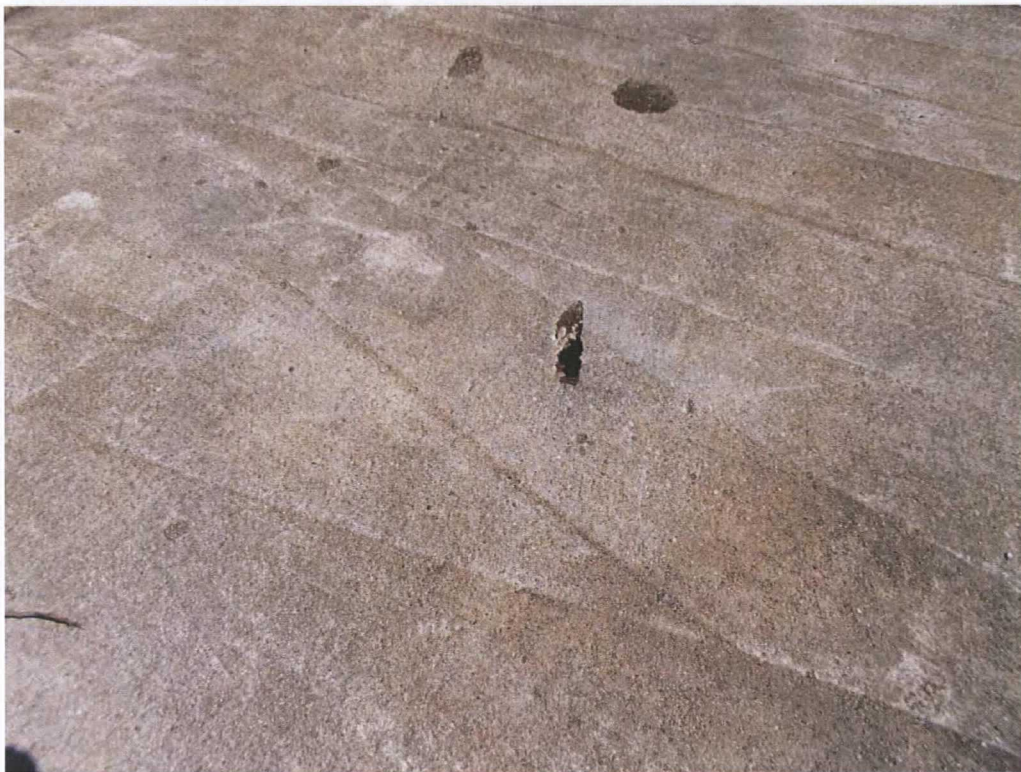
Void on interior area of pavement

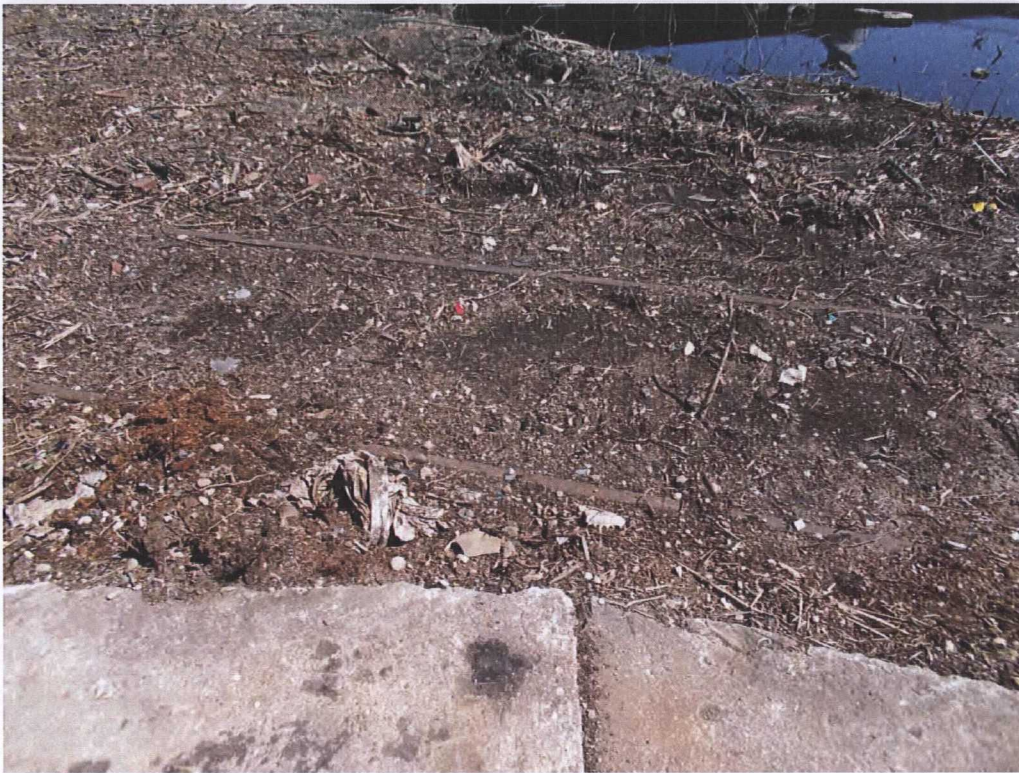
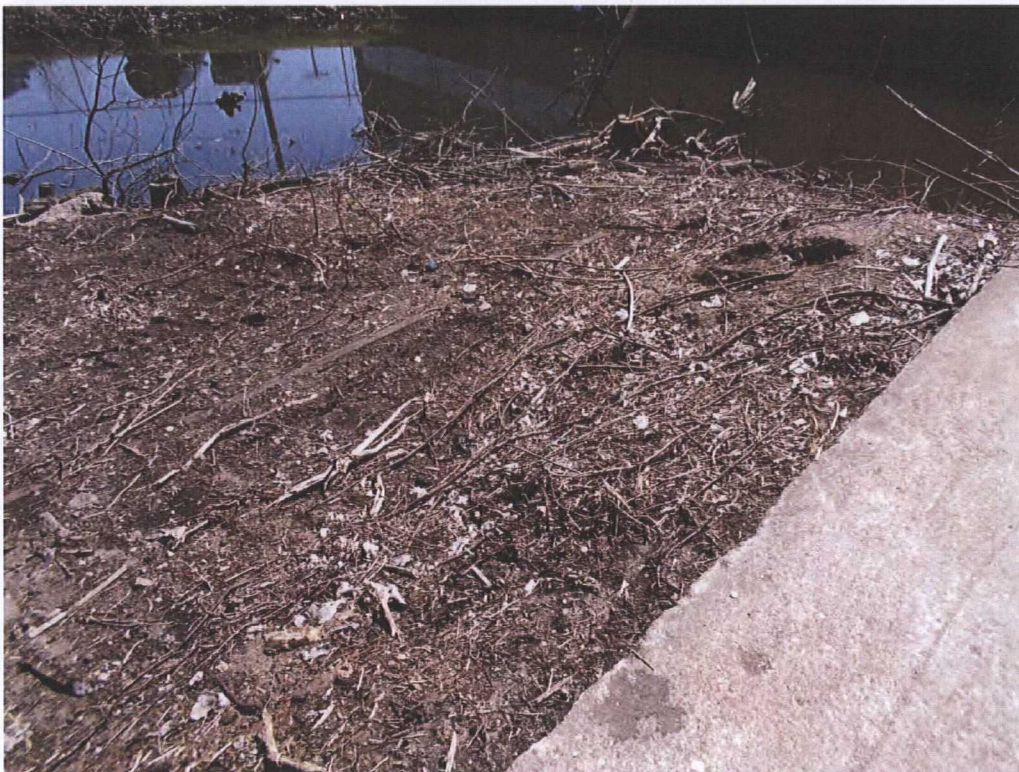
- The track appears to be in fair condition, however, the rails are almost completely covered with soil and debris.

View of track from adjacent pavement

View of track looking southeast

- The track appears to be abandoned. Any damage done during sediment removal operations does not likely need to be addressed.

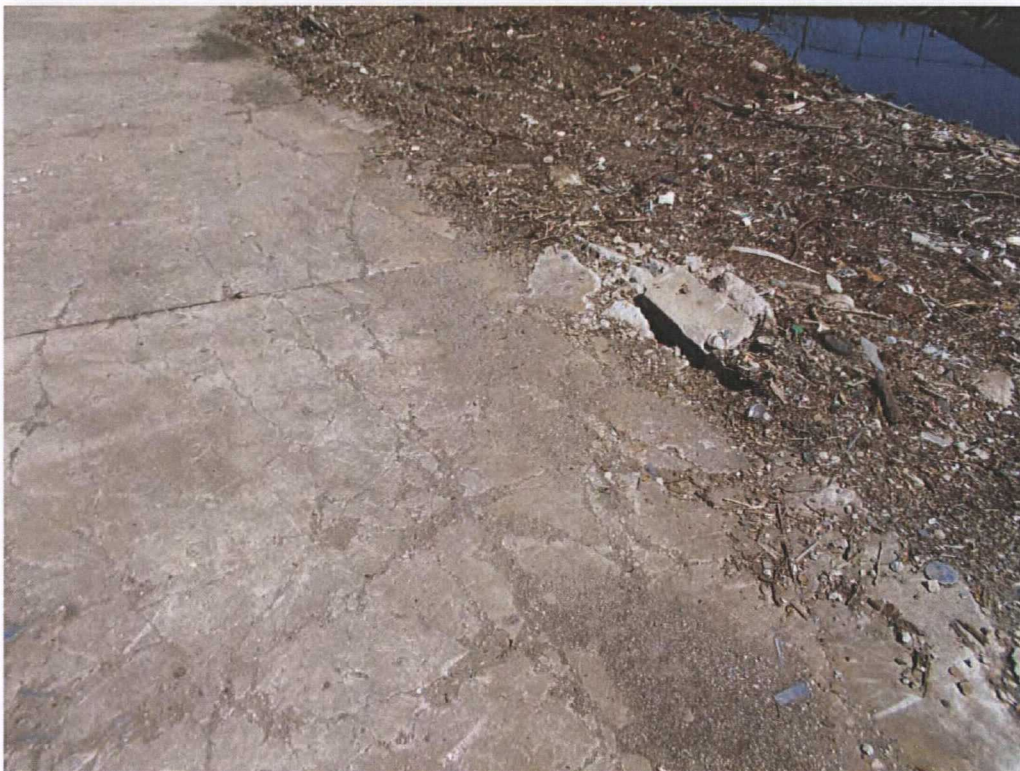
- The pavement is in critical to failed condition with alligator cracking and spalling throughout.

Severe cracking and spalling of pavement

- The pavement appears to be abandoned. Any further damage done during sediment removal operations does not likely need to be addressed.

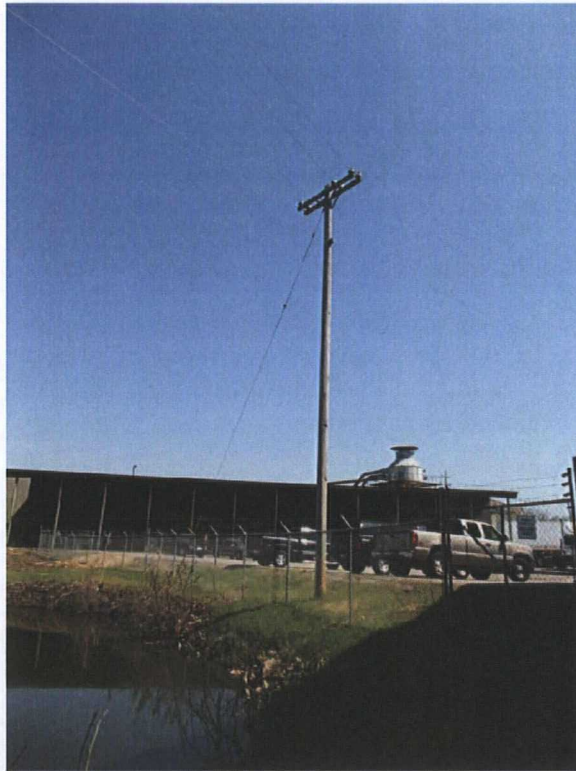
- The pole is weathered but otherwise appears to be in fair condition.

View of pole and guy looking northeast

- The pole appears to be beyond the influence of the sediment removal in the area. However, the guy is located near the water's edge. Sediment removal should be avoided within the 1:1 influence of the guy unless the pole is temporarily supported.
- Construction fencing or similar means should be used to identify the pole and guy to operators and drivers during the work.
- Due care should be used to avoid encroaching on the OSHA-mandated clearance for the overhead lines during sediment removal operations.

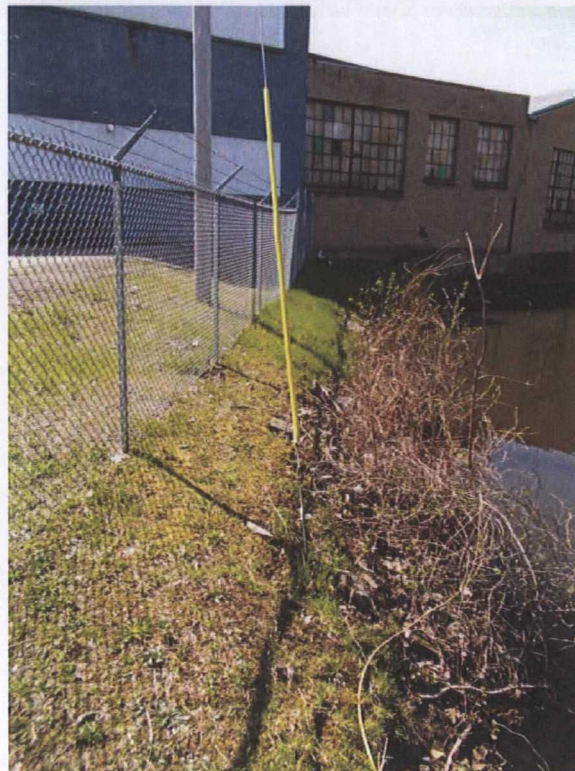
View of guy wire demonstrating proximity to the channel area

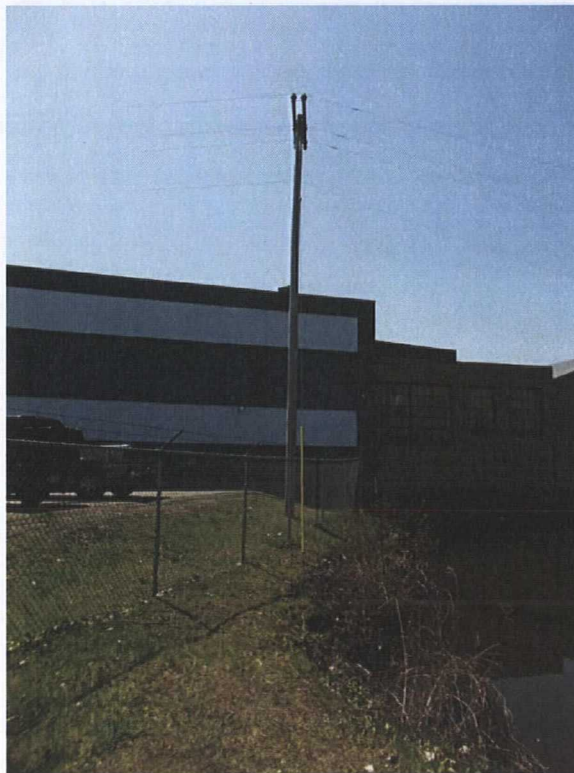
View of pole and guy looking south

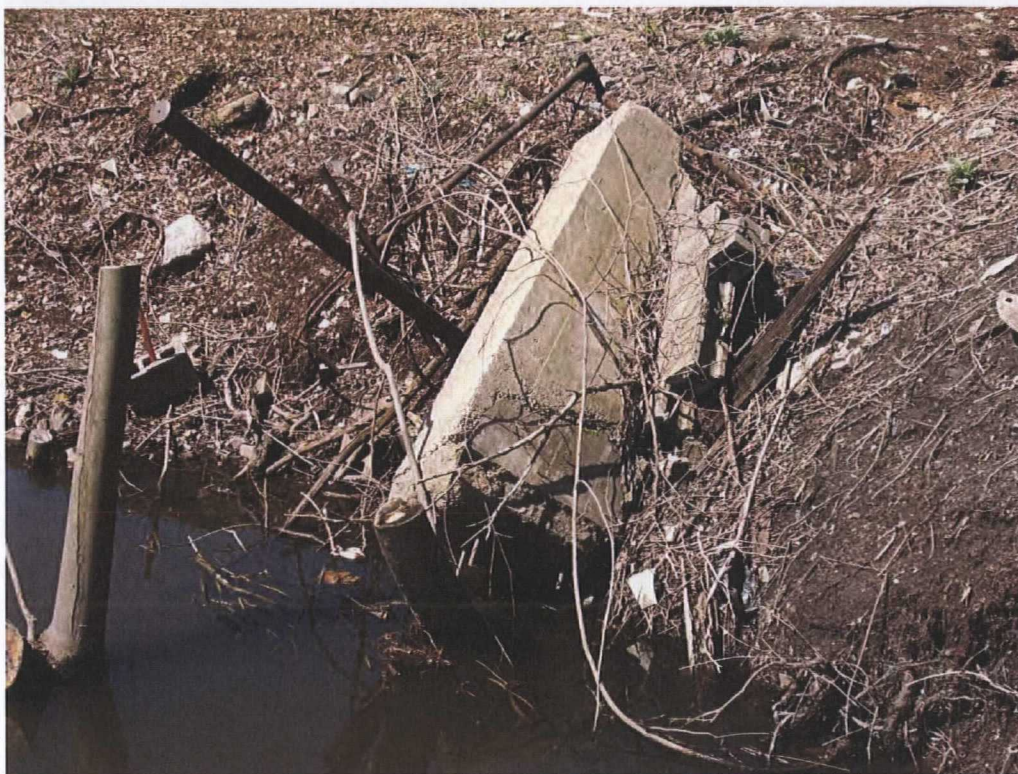
- The block and fence have failed and are falling into the channel area.

View of structure looking south

- It is likely that the block and fence can be removed in conjunction with sediment removal operations.

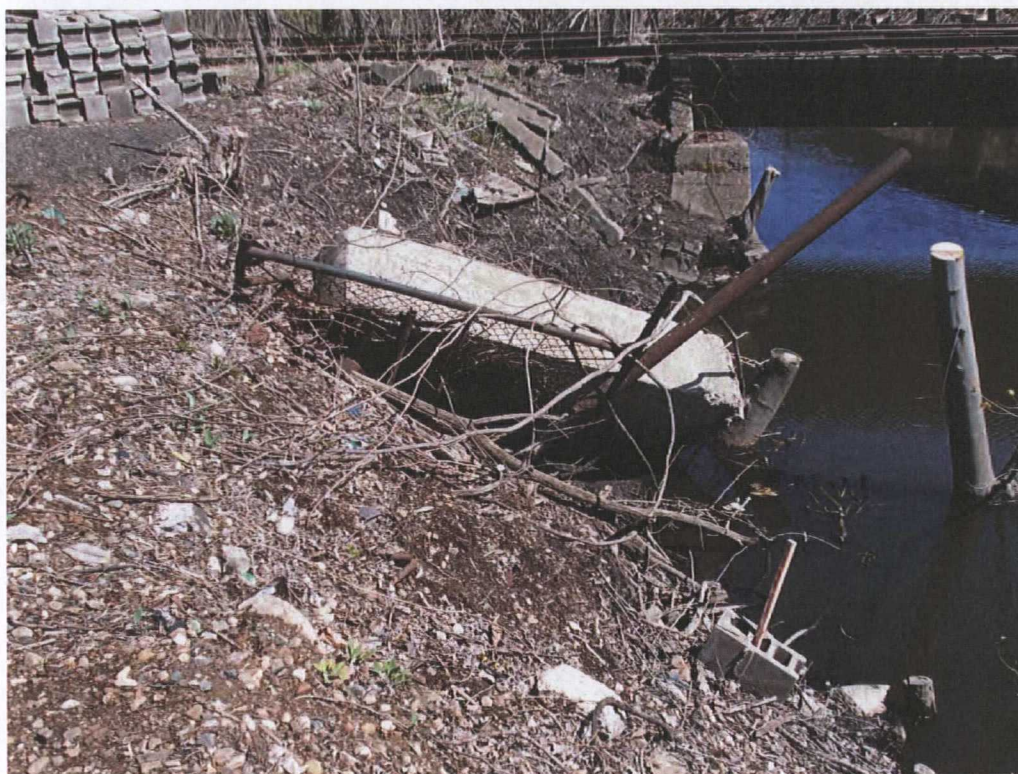
View of structure looking north

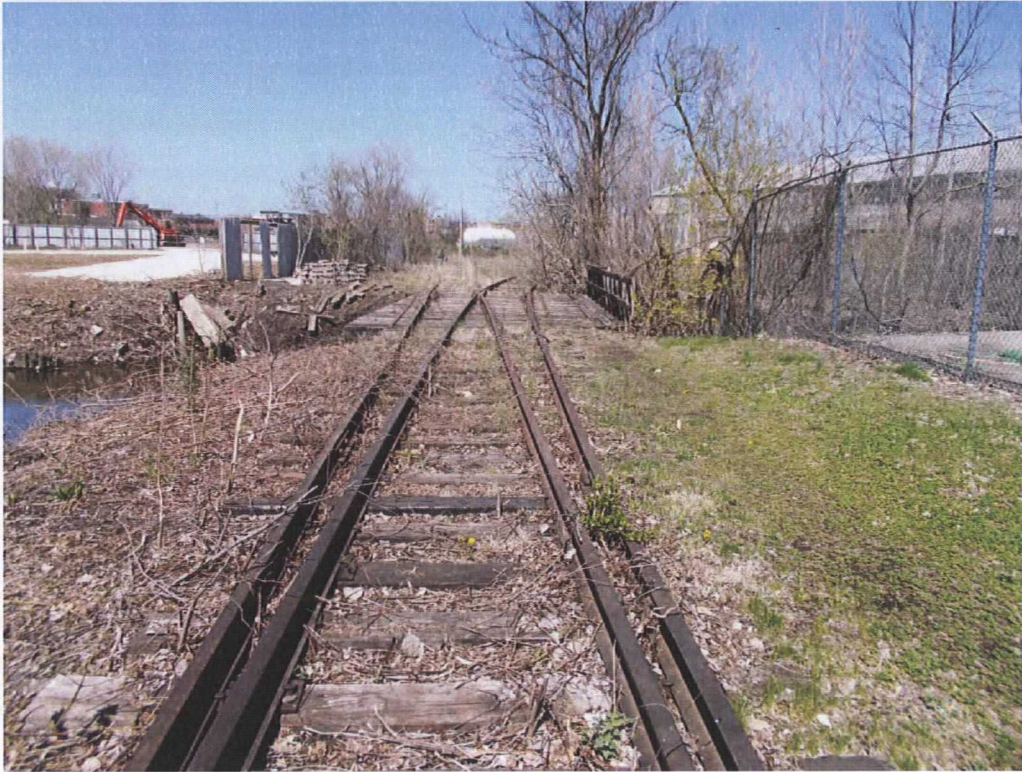
- The upper concrete abutments have moderate weathering. The lower stone abutments have grout voids, many of which have been patched. No undermining was detected.
- The steel beams have minor to moderate surface corrosion.
- Timber ties have severe to critical rot and section loss.
- The timber railing has a failed top plate the entire east half of the structure.
- The structure carries two sets of steel tracks, as it is located near a switch.
- Heavy brush is encroaching on the structure.
- Moderate to severe slope/bank erosion was noted all 4 quadrants. The channel spans abutment to abutment with no bank in place at the structure.

View of the structure from the southeast

- Due to the unknown foundation configuration, a minimum clearance of 5 feet is recommended for installation of the northern sheet pile wall. However, because the structure appears to be abandoned, settlement is not likely a significant concern if less clearance is required.

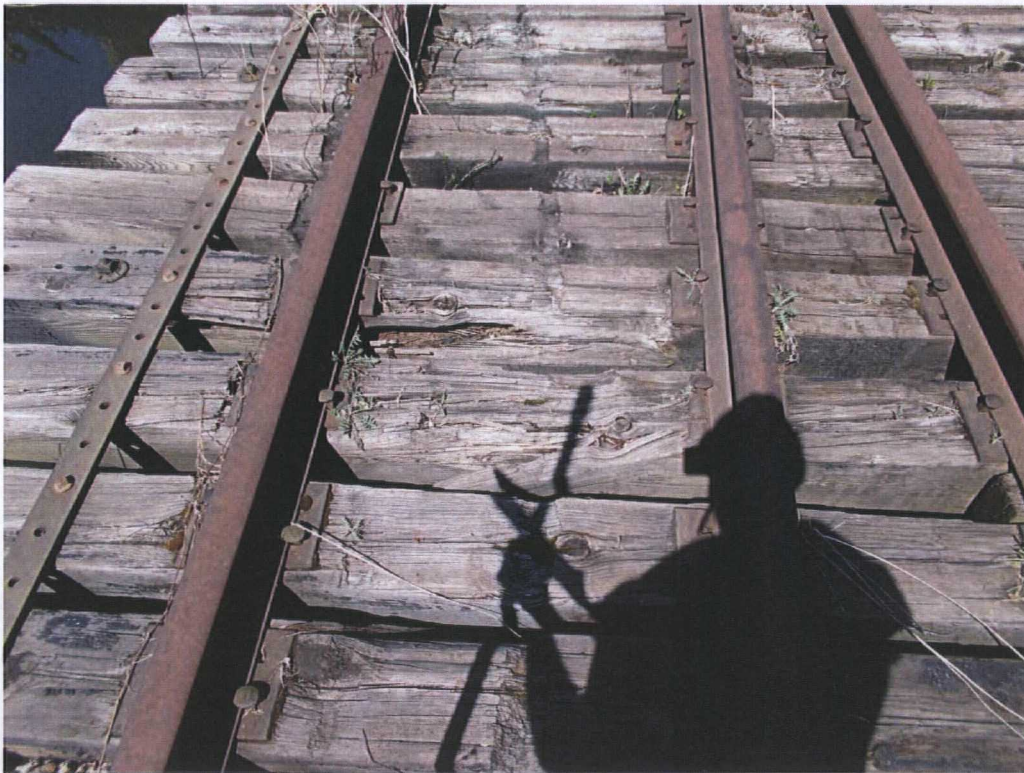
Severe section loss on timber ties

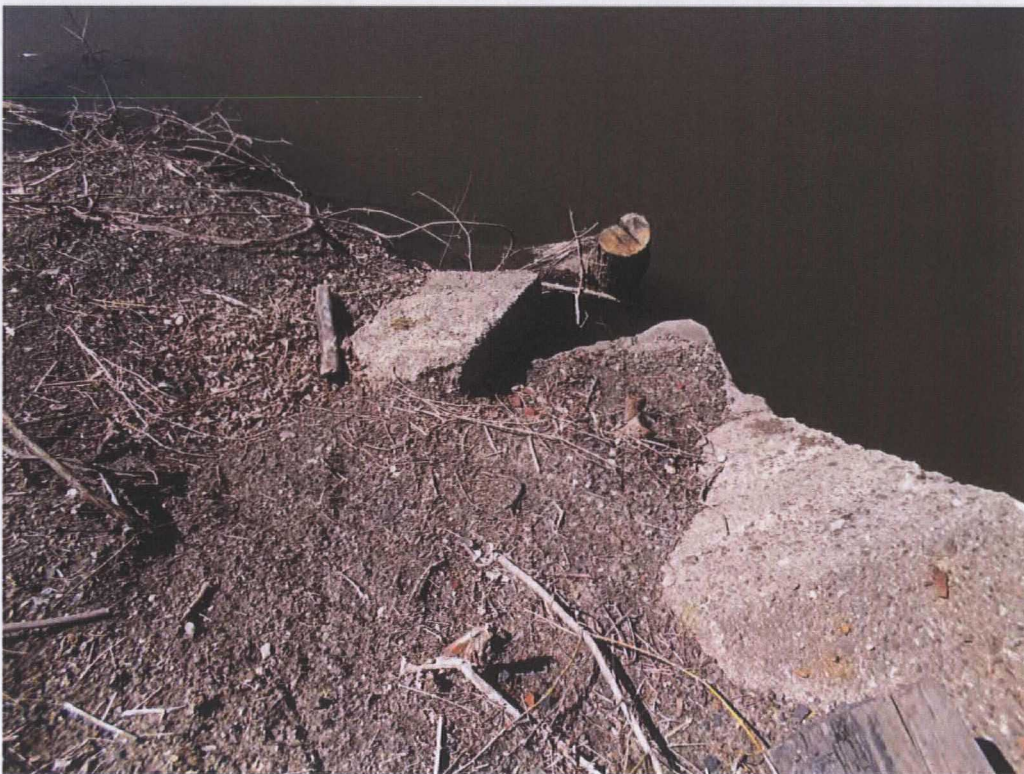
Bank erosion around corner of structure

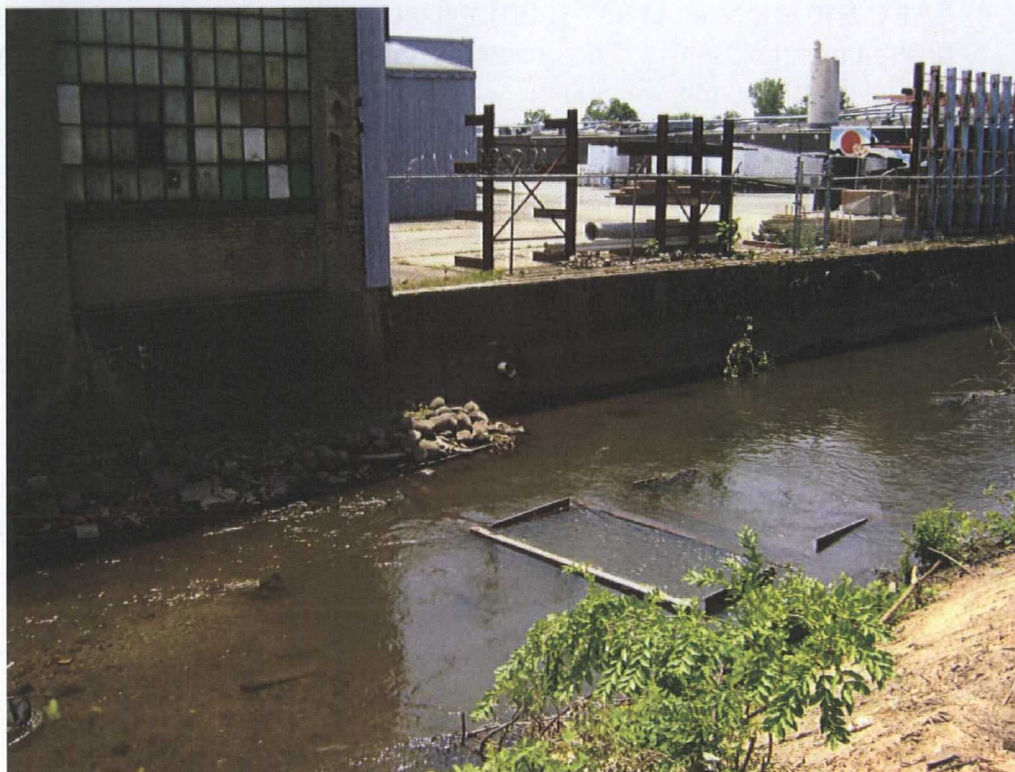
- The top of the pipe has been broken over approximately half of the length that extends from the concrete retaining wall.

View of the outlet from the north bank with bypass sumps in the foreground

- Because it is located upstream of the cofferdam and above the water line, any flow from the outlet will be handled by the adjacent bypass pumping. Therefore, an isolation cofferdam is not required.

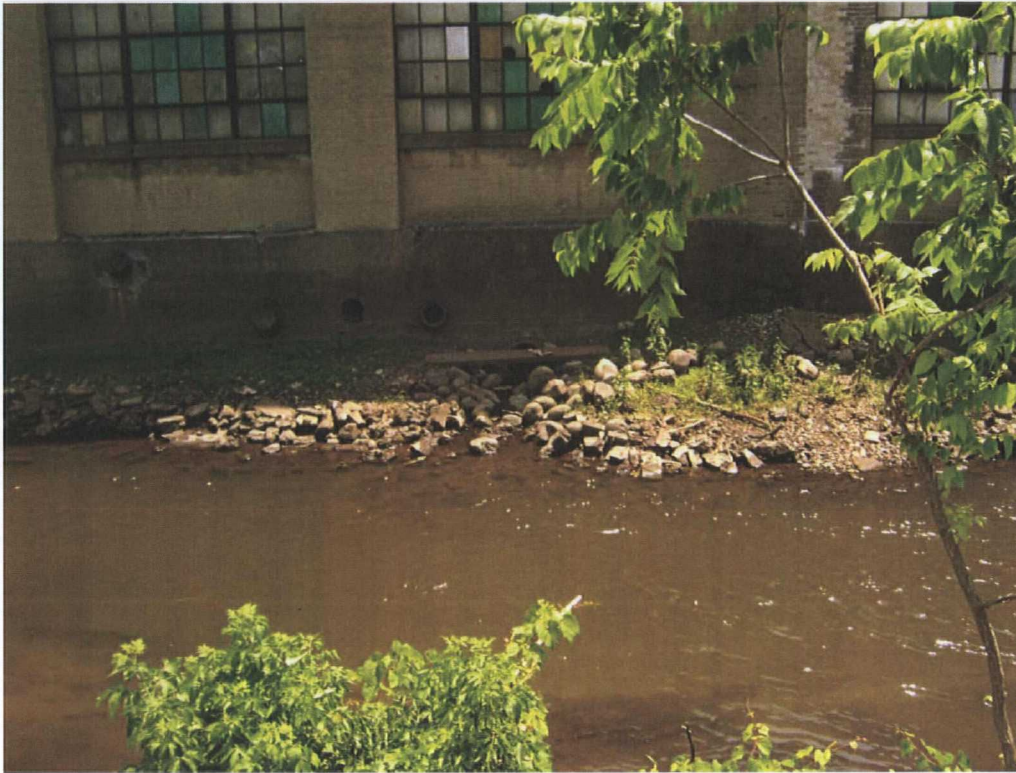
- The outlets appear to be in fair condition. The easternmost outlet has been abandoned.

View of the outlets from the north bank

- Because the outlets are located upstream of the cofferdam, any flow from the outlet will be handled by the adjacent bypass pumping. Therefore, an isolation cofferdam is not required.

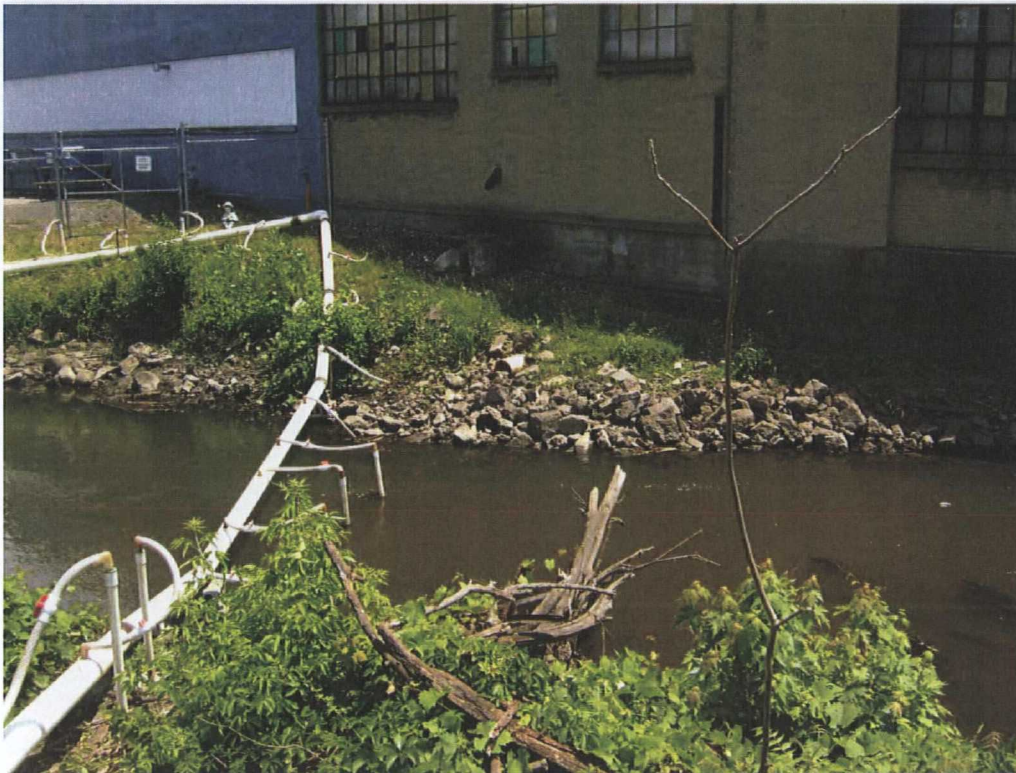
- The outlet appears to be in fair condition. Approximately 2' of the top of pipe is exposed.

View of the outlet from the north bank (dewatering equipment on the left)

- If an isolation cofferdam is required, it should be placed with a minimum 3 feet clearance to the outlet.

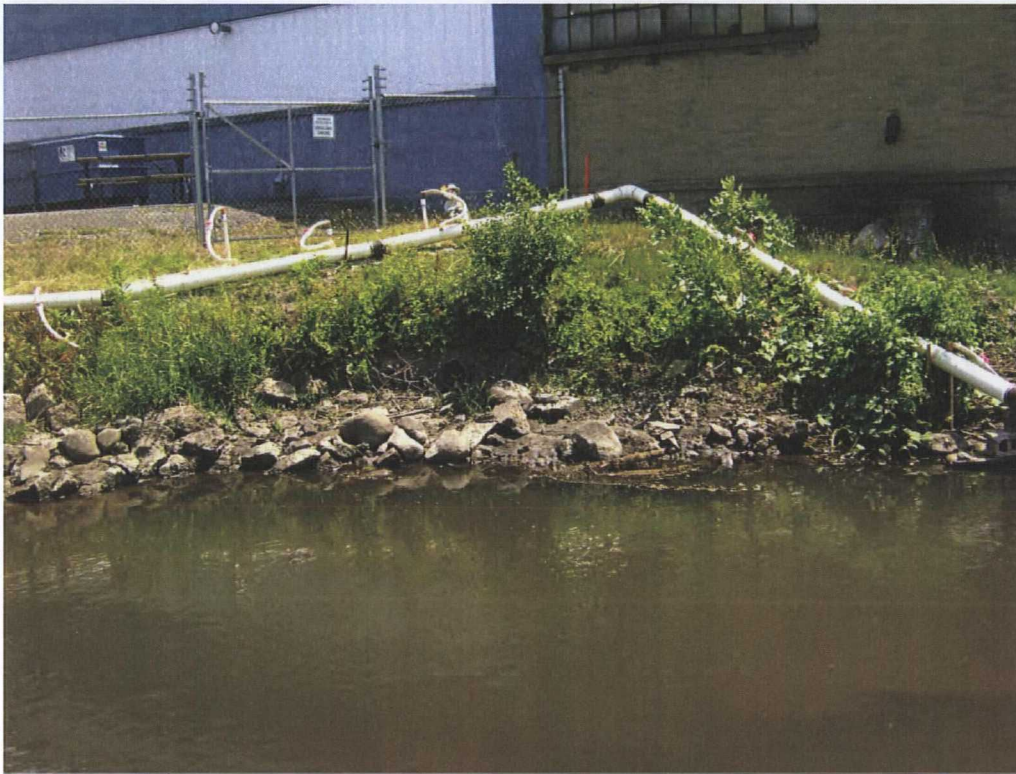
- The outlet appears to be in fair condition. The top of the end of the pipe has a small spalled area.
- The headwall is overgrown with vegetation.

View of the outlet from the north bank (dewatering equipment behind)

- If an isolation cofferdam is required, it should be placed with a minimum 4 feet clearance to the outlet and headwall.

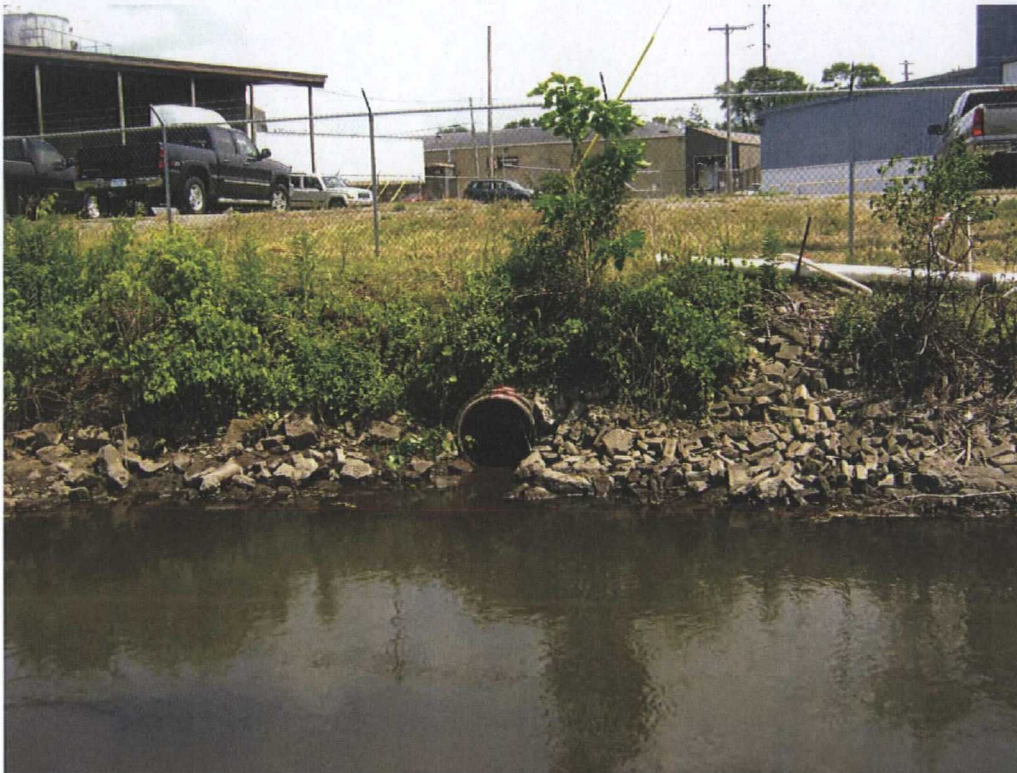
- The outlet appears to be in fair condition. No undermining is evident.
- The outlet is becoming overgrown with vegetation.

View of the outlet from the west bank (dewatering/bypass equipment behind)

- Due to its size and proximity, an isolation cofferdam is likely required to bypass wet weather flows. Maintain a minimum 3' clearance from the outlet with the cofferdam structure.
